Application Focus

Chemical Attack - Concrete

Application Case Study

Chemical Containment Repair & Protection Solution

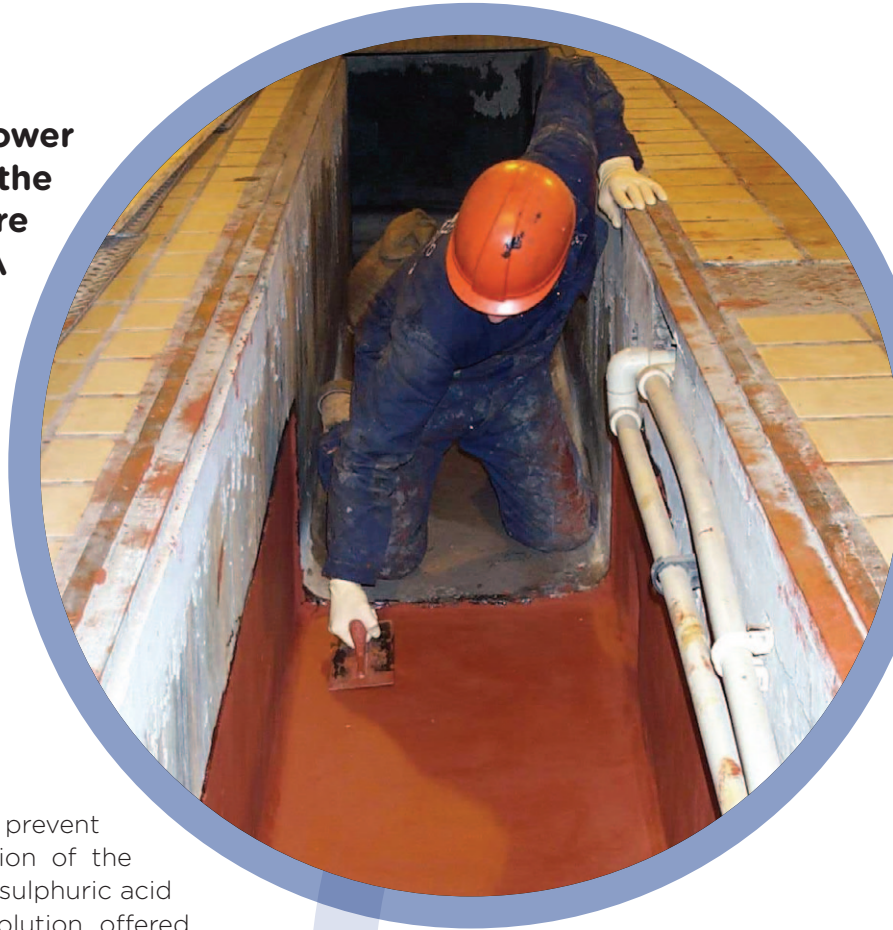
“ An inspection of a nuclear power station discharge sluice found the concrete to be suffering from severe deterioration due to acid attack. A previously applied cementitious screed had been damaged due to impact. Subsequently the acid penetrated the concrete, attacking the underlying substrate leaving large voids in the sluice channel. ”

Belzona® provided a cost effective solution to prevent chemical attack and reduce further deterioration of the sluice channel which was frequently exposed to sulphuric acid above ambient temperatures. The Belzona® solution offered greater impact and chemical resistance that provided long term protection of the sluice channel. **The work undertaken enabled a fast return to service of the channel, which ensured minimal disruption to the power station operations team.**
