# Self-Lubricating Metal Repair System

Belzona 1131 (Bearing Metal) is a 100% solids paste-grade repair system with self lubricating properties for creating low-friction surfaces subject to intermittent contact and low specific loads.

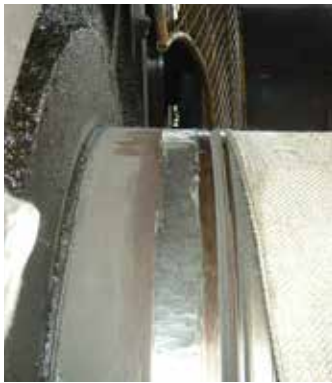
Worn seal area

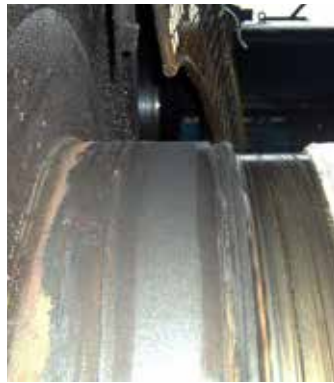
Seal area repaired

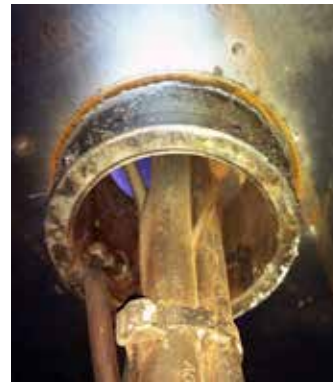
Corroded shaft

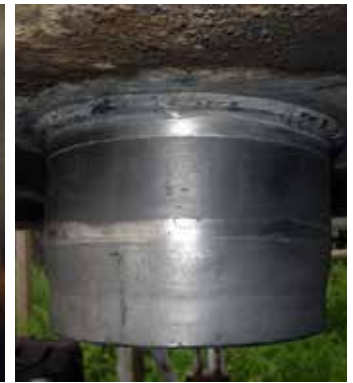
Shaft rebuilt
